A Case Study
on
A Case Study on Community-Driven Transformation of Seth Chuhimal Ki Chatri And Talab

Nuh Rural Haryana

School of Architecture and Design
K R Mangalam University, Sohna Road, Gurugram, Haryana

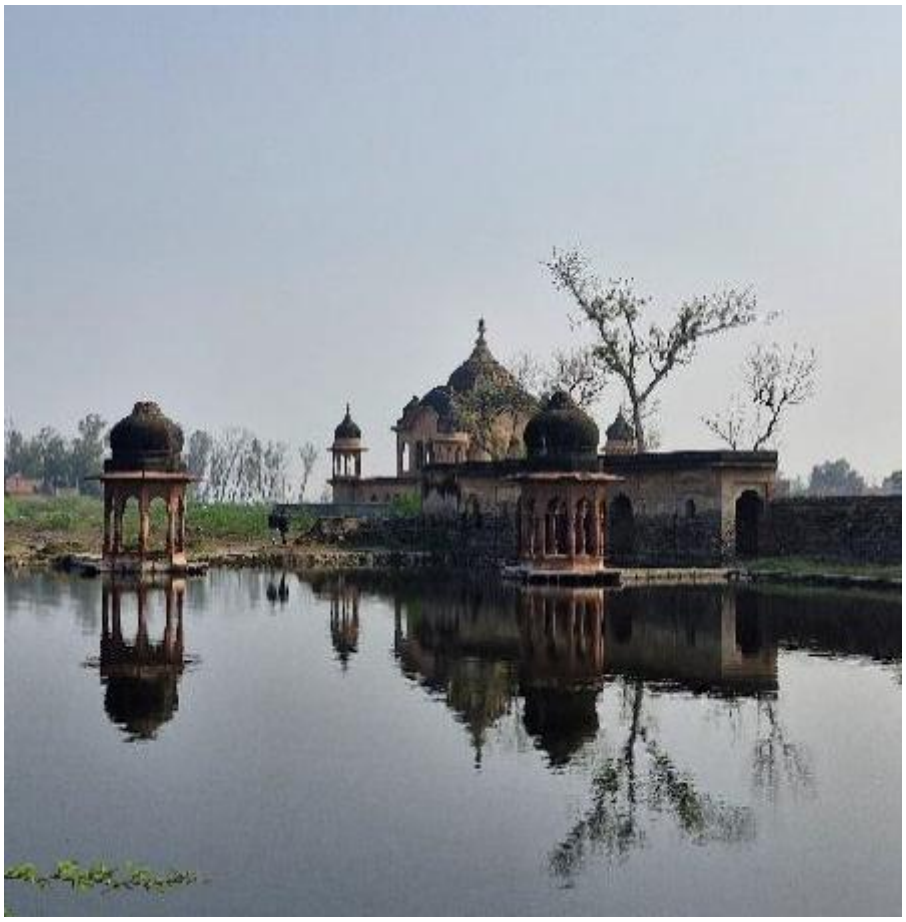
Fig12: Designed for rain harvesting
Source-Author
