A Case Study on Community-Driven Transformation of Seth Chuhimal Ki Chatri And Talab

Nuh Rural Haryana

Under the '**CREAT**' initiative

School of Architecture and Design

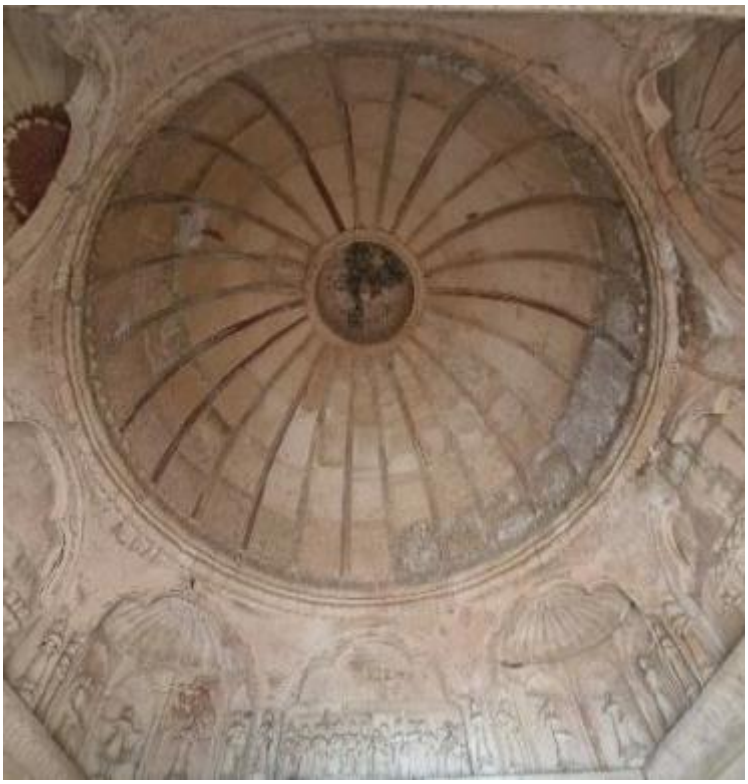
Fig.7: Domes supported by finely carved stone columns
Source- Author

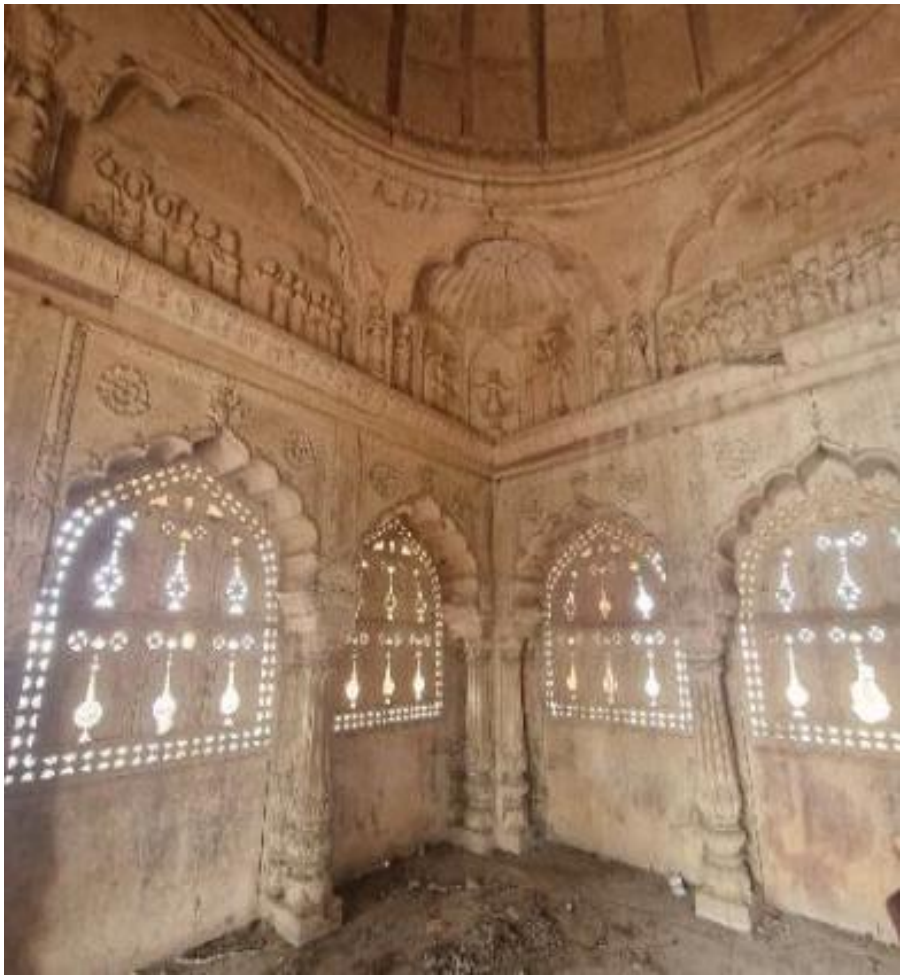
Fig.8: Perforated jali screens enabling cross-ventilation
Source- Author

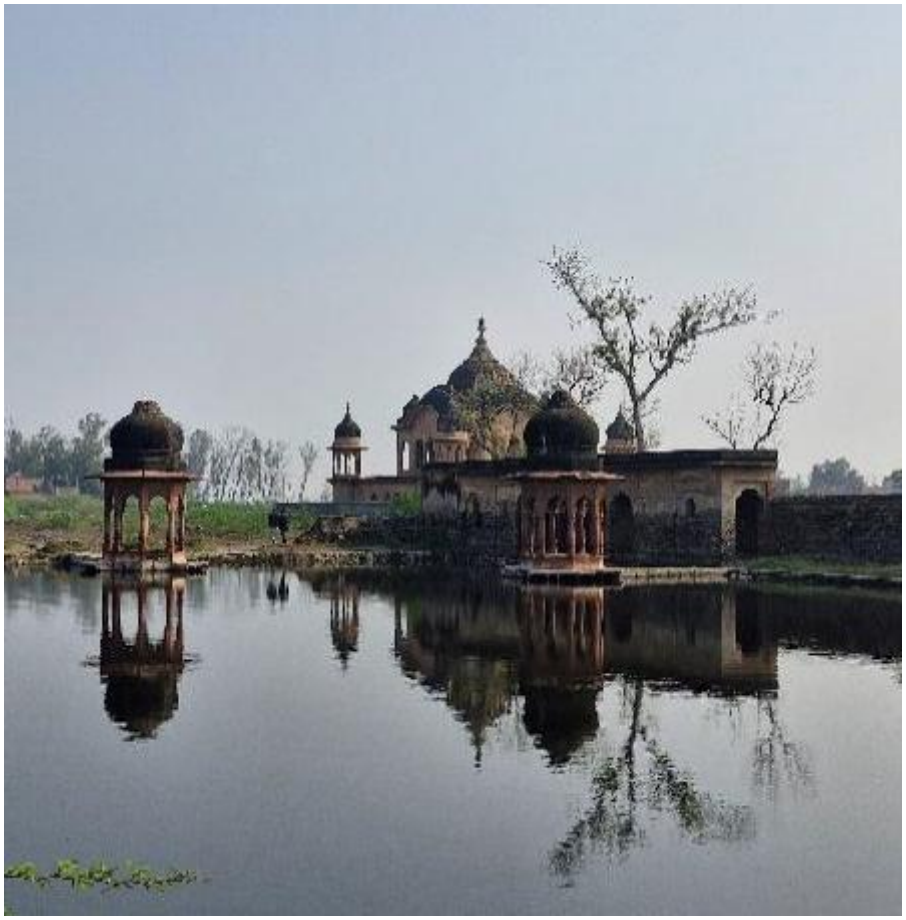
Fig 11: Balanced layout for aesthetics and functions

Fig12: Designed for rain harvesting
Source-Author

Fig13: Step well-style reserved with descending stone step.
Source-Author

Fig 14: Structural Deterioration
Source-Author
